MOLOK EXPLOSION TESTS

Artillery Brigade's test firing establishment conducted an explosion test for MOLOK containers in Niinisalo 9.12.2009. The purpose of the test was to determine the behavior of the container, spreading of pieces to the surrounding areas, and the influences of pressure wave when a charge was exploded inside the container. The test was done with three container models; CityScape, Basic container 3000I and MolokDomino.

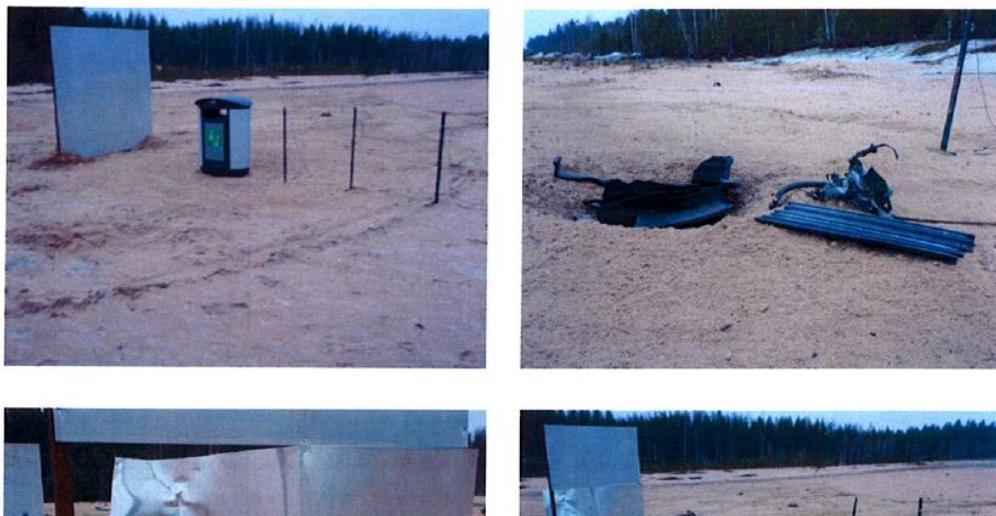
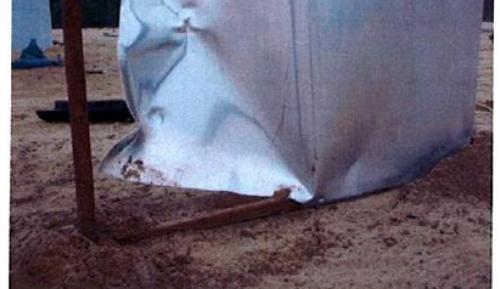
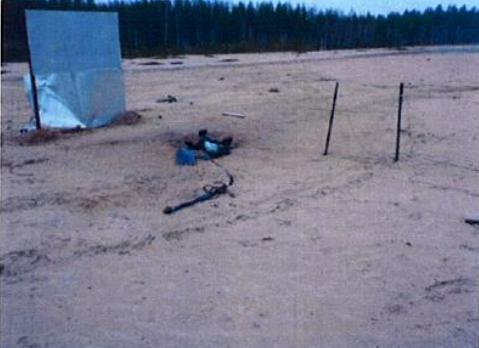
Pictures of CityScape

- The parts above ground were broken and they flew to surroundings due to the pressure
- The explosion caused a 25 cm in depth and 1,5 m wide hole to the place of the container
- The parts underground broke in to several pieces, but they stayed at the same place.
- An article separated from the side of the container and flew through the proof panel, bending the panel loose from its framing.
- The footage from the thermo camera was not saved due to an error in the program.

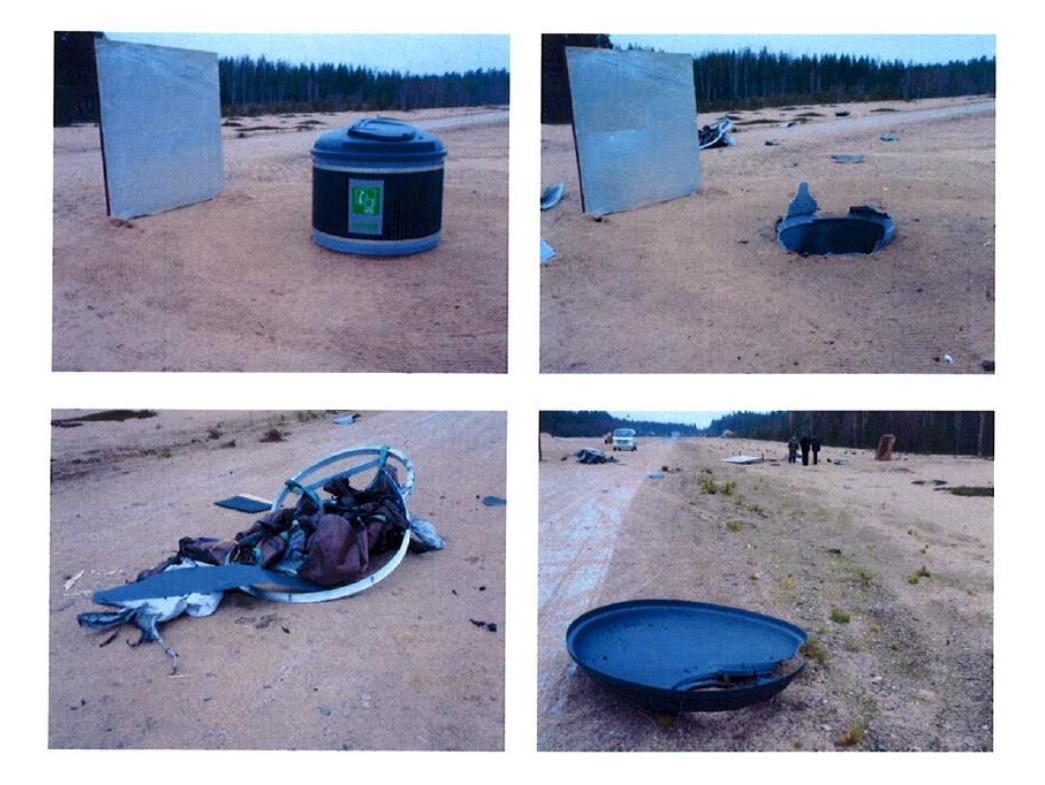
Pictures of Molok 3000l

- The parts above ground were broken and they flew to surroundings due to the pressure
- An article separated from the side of the container and flew to the proof panel causing a 1 cm deep trace to the area of 50 cm x 5 cm
- No hole to the ground
- The parts situated underground broke slightly but stayed at the same place

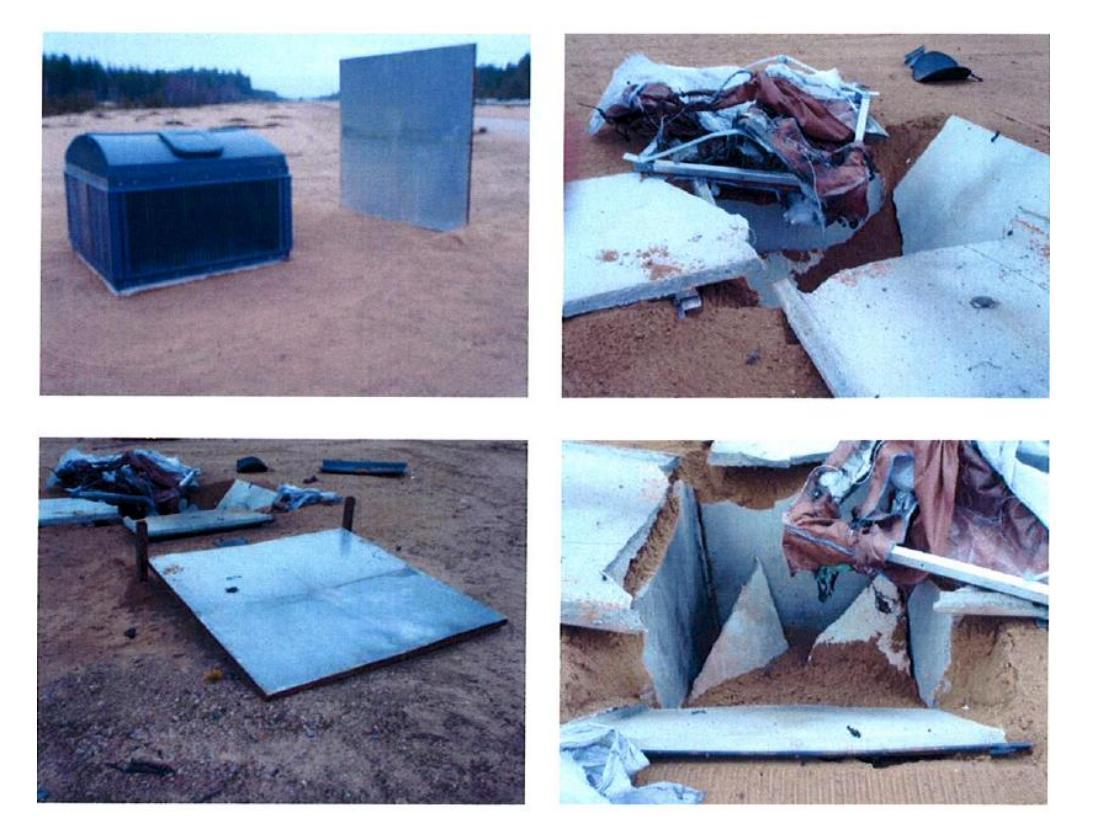
Pictures of MolokDomino

- The concrete parts on ground level broke in to four separate parts falling on the edges of the pit and partly in to the pit.
- The parts underground broke in to few large parts, which stayed in the pit.
- The metal frame from the top of the container remained in form and flew straight upwards falling partly on the pit
- There were no detectable marks on the proof panel; however the proof panel fell down probably because of the pressure.
- No hole to the ground
